## Unreviewed Safety Question Activity Report

2006-1

Office of Facility Safety (EH-2)

January – March 2006

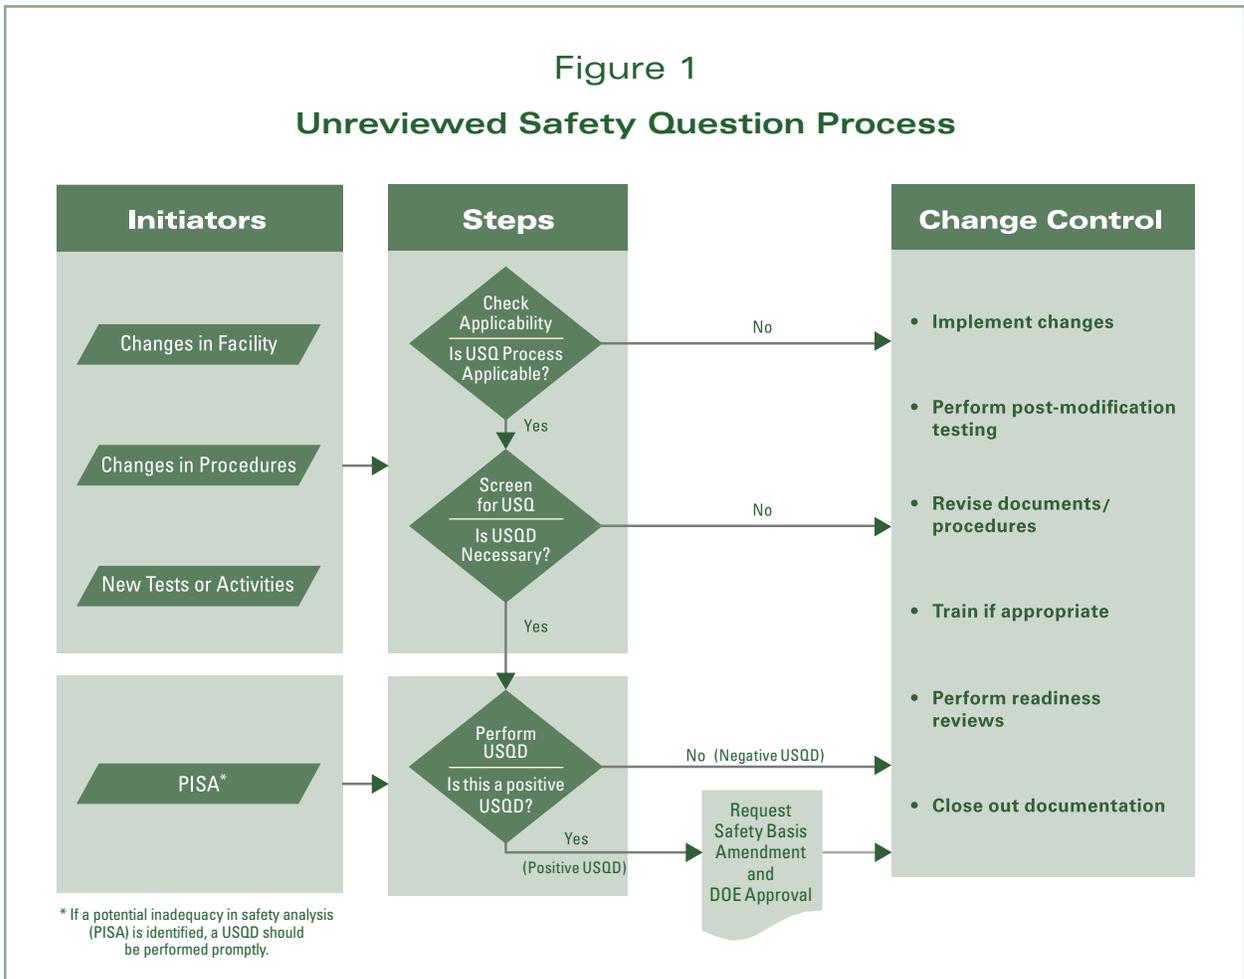
**Figure 1**  
**Unreviewed Safety Question Process**

The Unreviewed Safety Question (USQ) process alerts the Department of Energy (DOE) to events, conditions, or actions that are not within the DOE-approved safety basis of a facility or operation and ensures appropriate DOE line management action. Figure 1 shows the steps in the USQ process.

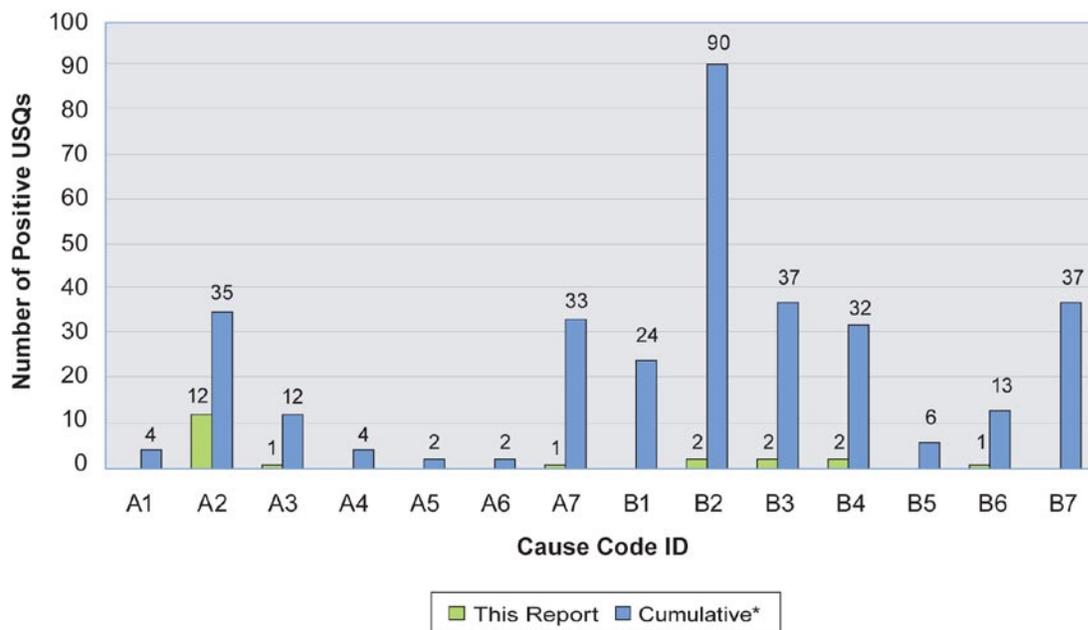
**Figure 2**  
**Grouping of USQDs by Cause Code**

\* For the period from March 2001 – March 2006. The cumulative number of USQs equals 331.

From January through March 2006, there were 21 positive USQDs across the DOE Complex. The results of the team’s review of the USQDs are discussed below. Specific details for each USQ (in tabular form) are provided in Appendix A. Figure 2 shows USQs reported for this period and the cumulative period from March 2001 through March 2006, grouped by the cause codes defined in Table 1 (page 8). Figure 3a shows the percentages of USQs by cause code for the period of January through March 2006, and Figure 3b shows the percentages of USQs by cause code for the cumulative period of March 2001 through March 2006.

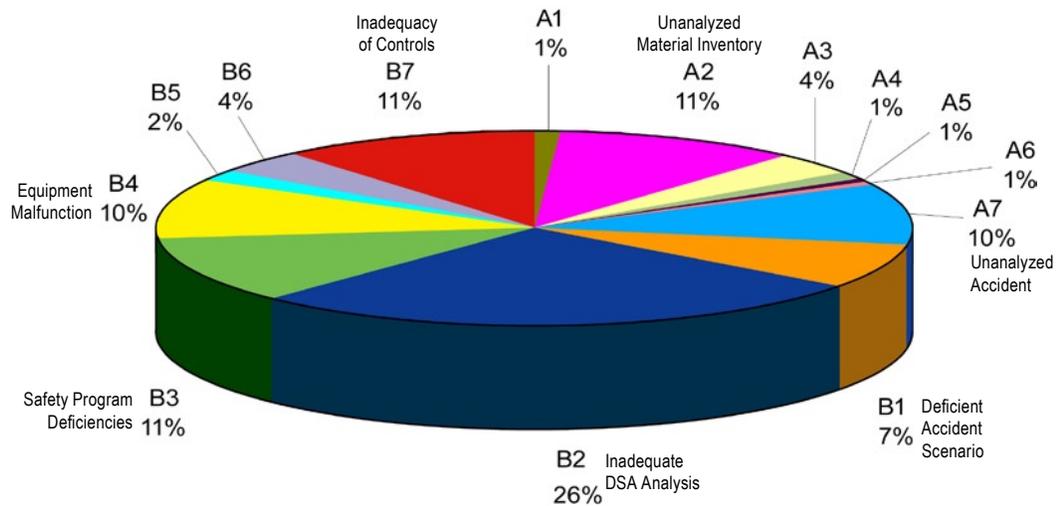
**Figure 3b**  
**Percentages of USQs by Cause Code**  
 (Cumulative\*)

Note: For the Cause Code definitions, see Table 1 on page 8.  
 \* For the period from March 2001 – March 2006
